## Surface density of growth defects in different PVD hard coatings prepared by sputtering

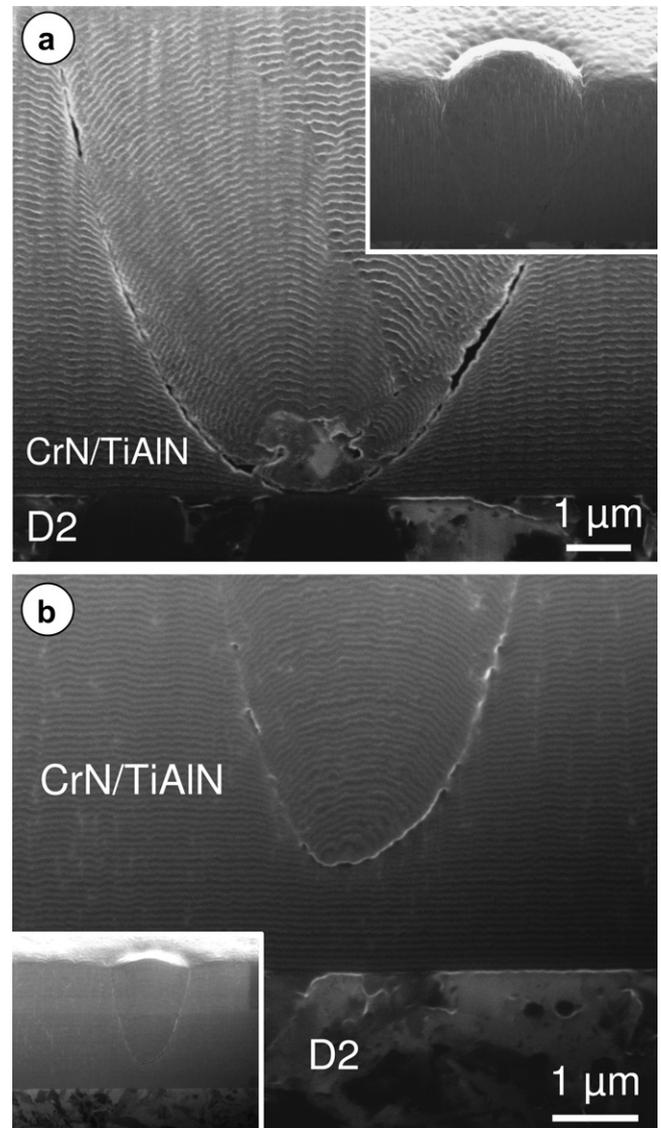
Fig. 1. SEM images of FIB cross-section of nodular defects in the TiAlN/CrN nanolayer coatings.

Figs. 1 and 2 show FIB and SEM images of typical growth defects found in the TiAlN, TiAlN/CrN and AlTiN/TiN nanolayered coatings. Nanolayered coatings are especially useful for investigating the defects because the layer structure reveals the origin of the defects and their influence on the coating growth. SEM images on FIB cross section (Fig. 1) show that nodules have the form of a cone protruding above the coating surface. Nodular defect shown on Fig. 1a started to grow on the substrate surface on a seed which remained on the substrate surface. Fig. 1b shows an example of a nodular defect which started to grow in the middle of the coating due to the incorporation of a foreign particle during the deposition process.

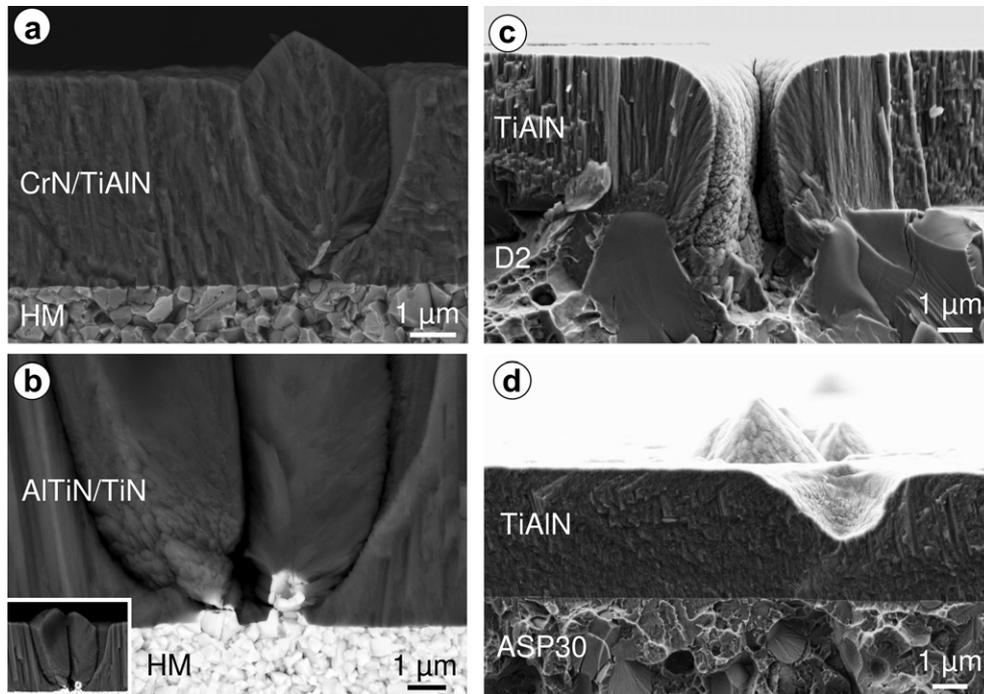
Fig. 2. SEM images of a nodular and pinhole defects in the TiAlN, TiAlN/CrN and AlTiN/TiN nanolayer coatings.

Fig. 2a shows cross-sectional backscattering electron micrographs of the TiAlN/CrN nanolayer deposited on cemented carbide. The seed which juts out from the substrate surface is clearly visible (in this case the seed is small part of tungsten carbide which

remained on the substrate surface after mechanical pretreatment). An example of a very interesting nodular defect is shown on Fig. 2b. Cross-sectional SEM micrograph of the TiAlN/TiN nanolayer coating on cemented carbide shows that the nodular defect nucleated on two seeds (very small surface asperities, which remain on the substrate surface after its mechanical pretreatment). A typical internal structure of the nodules is also visible. The microstructure of the coating in the nodule is substantially different in comparison with that of the surrounding matrix. It can also be seen that the boundary between the cone-shaped defect and the coating is highly porous. Fig. 2c shows defects in the form of pinholes generated at the substrate pit (cavity), formed during polishing. It is too large to be closed by the deposited hard coating. On Fig. 2d there is an example of a dish-like hole forming when a coated foreign particle flakes off due to high stress in the coating.

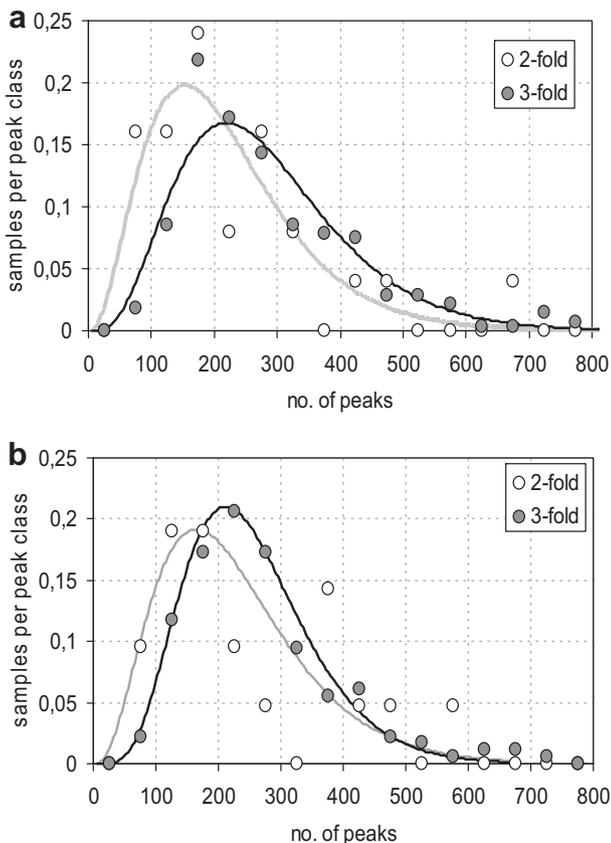
Fig. 3. Distribution of defect density for TiAlN (a) and AlTiN/TiN (b) nanolayer hard coatings deposited on cemented carbide substrates.

From a large number of measurements we performed an elementary statistical analysis in order to evaluate the defect surface density for a desired coating (Fig. 3). The number of measurements is quite large (500 in total) and the number of defects per area often scatters considerably in the same series of samples. Therefore a statistical analysis is necessary to extract the overall results. A suitable distribution has to be fitted to the acquired measurements rather than taking a simple average where isolated outliers can spoil the final value considerably.

Fig. 3a shows the distribution of all the samples coated with TiAlN, divided in two series based on the type of rotation. The 3-fold rotation gives a good fit, which is partly a consequence of a large number of samples. The peak of the distribution is located at  $220\ \text{defects}/\text{mm}^2$ . In 2-fold rotation there is more scattering but the overall form is still in good agreement with the Poisson

distribution. The peak is located at a significantly lower value, at  $150\ \text{peaks}/\text{mm}^2$ . The same analysis was performed also on AlTiN/TiN nanolayer coatings for samples prepared using 2- and 3-fold rotation. In comparison with TiAlN we did not find any significant difference in peak location. We also analyzed the samples mounted at the same position in the vacuum chamber on the holder which assured 1-, 2- and 3-fold rotations. We found (see Table 1) that the difference in defect density between all the three samples from the same batch was rather high (up to 200%). Samples from different batches were analyzed and the results are randomly distributed regarding the rotation type. There can also be a substantial difference (up to 50%) on the two faces of the same 3-fold rotated sample. The results of all these measurements show that the formation of significant share of the defects is spatially localized and sporadic.

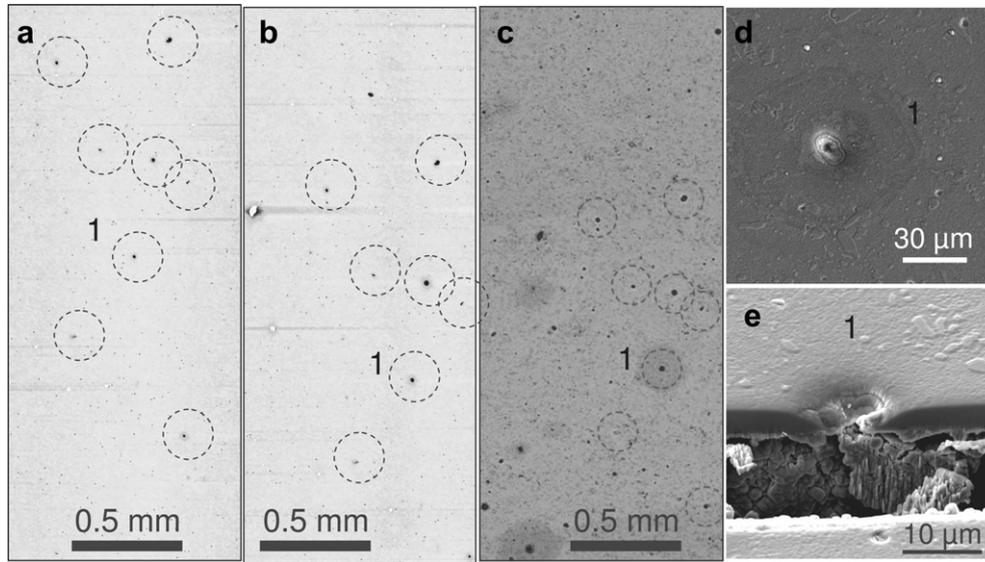
**Fig. 4.** 3D profilometry image of TiAlN coating on D2 tool steel before (a) and after corrosion test (b); optical image of the same area after corrosion test (c); SEM image of selected pinhole (number 1); FIB image of the pin-hole (number 1) cross-section after corrosion by backscattered electrons (e).

Due to the weak boundary between the nodular defects and the surrounding material some of them can become separated from the coating leaving a cavity. The ejection of a nodulus appeared when the coating is thick enough or if it is exposed to mechanical forces (e.g. sliding). A high concentration of such pinholes increases the coating porosity. The pinholes and the open structure between the nodulus and the surrounding coating are responsible for pitting corrosion (Fig. 4). A corrosion tests of PVD coatings, using

electrochemical methods (potentiodynamic data and with electrochemical impedance spectroscopy), were performed in chloride medium. Surface characterization was performed before and after corrosion test by 3D-profilometry, optical microscopy and FIB. After corrosion we performed profilometry over the same area as on the as-deposited sample, paying special attention to the position of the pinholes at which pitting corrosion occurred (e.g. pinhole 1 on Fig. 4). Then we also took optical images of the same area (Fig. 4c). By comparison of the 3D profiles and the optical image it is possible to identify the network of pinholes also on the optical image. We selected individual pits on the coating surface and made a slice-by-slice sectioning by FIB. The FIB image of pit (number 1) cross-sections after corrosion is presented on Fig. 4e.

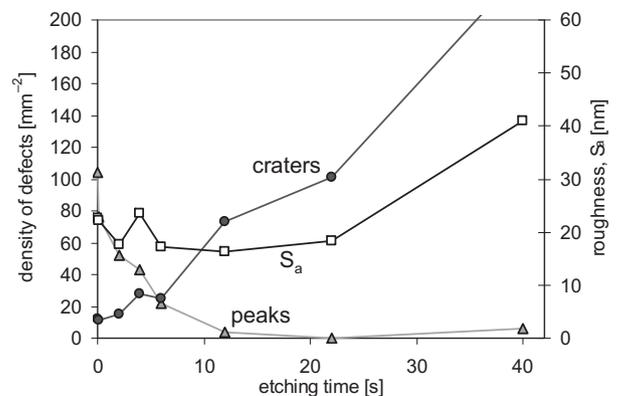
**Fig. 5.** Surface roughness, peak and crater density as a function of etching time during GDOES depth profiling of TiAlN hard coatings.

We performed compositional depth profiling of coatings using GDOES technique. The craters with different depths were prepared on selected coatings. The etching time was between 1 and 80 s. After GDOES experiment we evaluated the coating topography of the GDOES crater bottom using the 3D profilometer. We found that after short ion etching (a few seconds) all cones formed during coating deposition process transformed into holes. Fig. 5 shows the density of peaks and holes as well as surface roughness of the TiAlN coating deposited on tool steel as a function of etching time. Density of peaks rapidly decreases after a short etching time, while the density of holes increases simultaneously. This effect can be explained by the reduction of the cohesive force between the inclusion and the coating after removal of the top layer and by high thermal stresses which appear during ion etching between the cones and the bulk coating. Namely, the electric field density on the conical defects is much higher compared to that of a flat surface. Thus an ion current with higher density appears which is responsible for higher local temperature and thermal stress. Such stresses

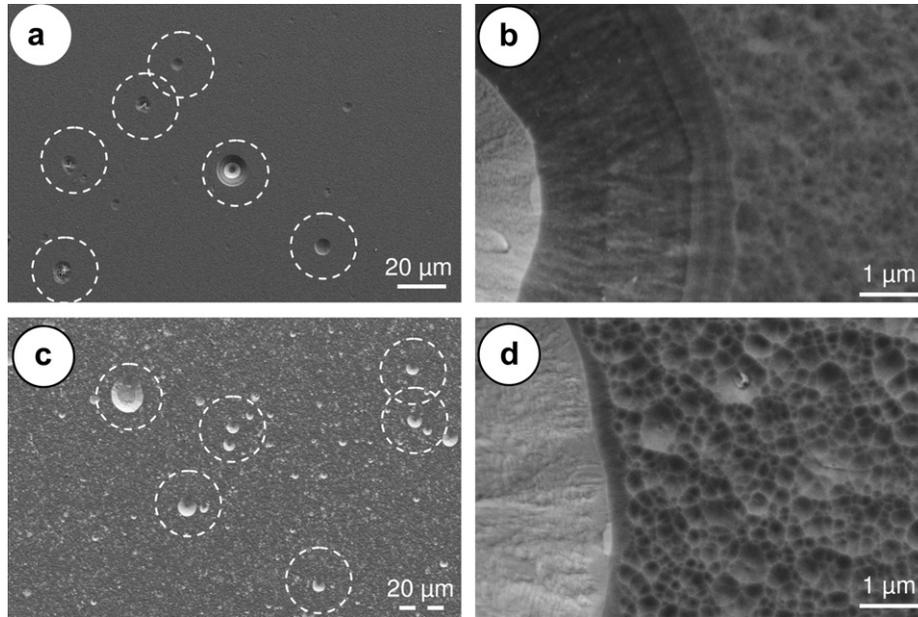
Fig. 6. SEM images of TiAlN hard coating in the GDOES crater after etching time of 6 s (a, b) and 45 s (c, d).

can cause the detachment of the coated particles (see craters on Fig. 6a,c). We found that the surface roughness is more or less constant during etching of fine-grained coating with homogeneous composition while it rapidly increases when the steel substrate starts to etch. The reason for roughness increase is the generation of surface features during ion bombardment of inhomogeneous tool steel material.
